Distresses in Bituminous Pavements

CE481A Project (Group 7)

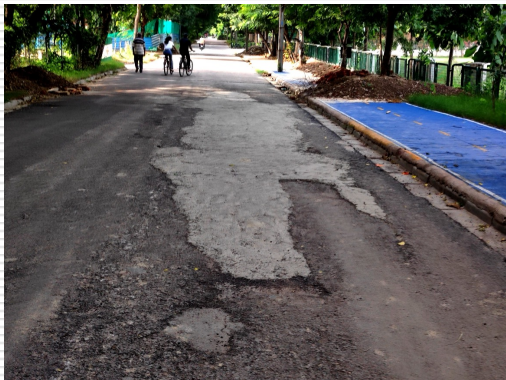
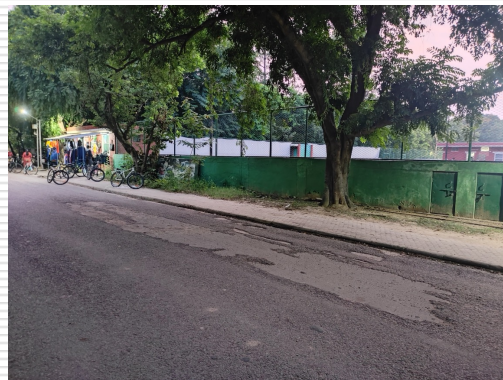
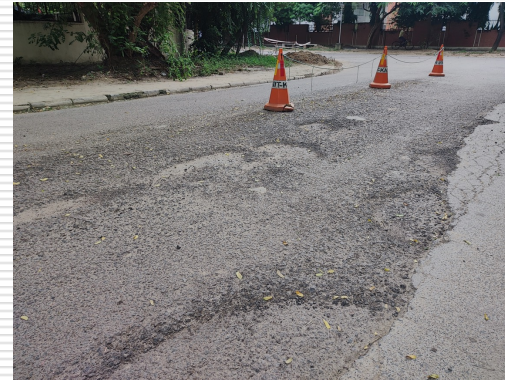
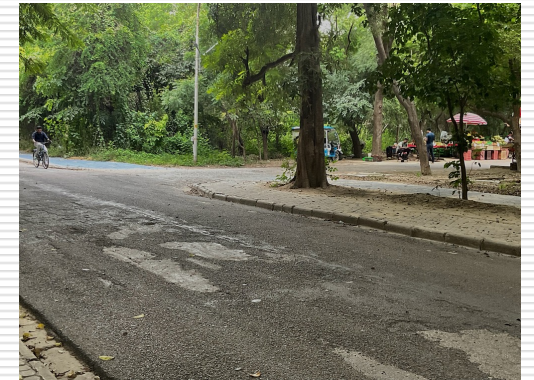
- Deterioration or damage caused to the pavement by
 - Traffic Loads,
 - Environmental Conditions &
 - Material Properties
- In most cases, measured per unit area

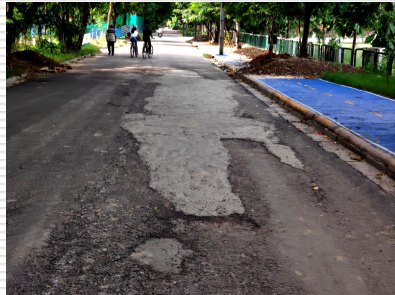
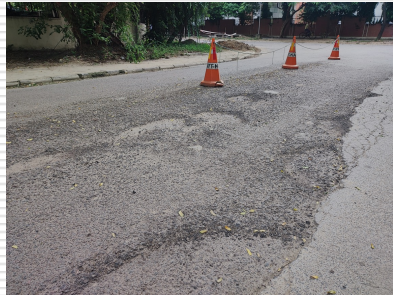
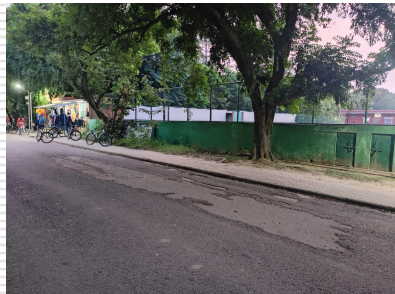
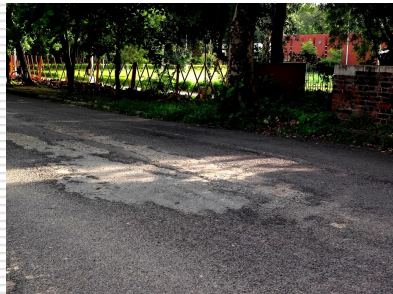
- Common Distresses: Fatigue, Rutting, Potholes, Raveling
- More distressed bituminous pavements (Poor Condition)
- Less distressed bituminous pavements (Good Condition)

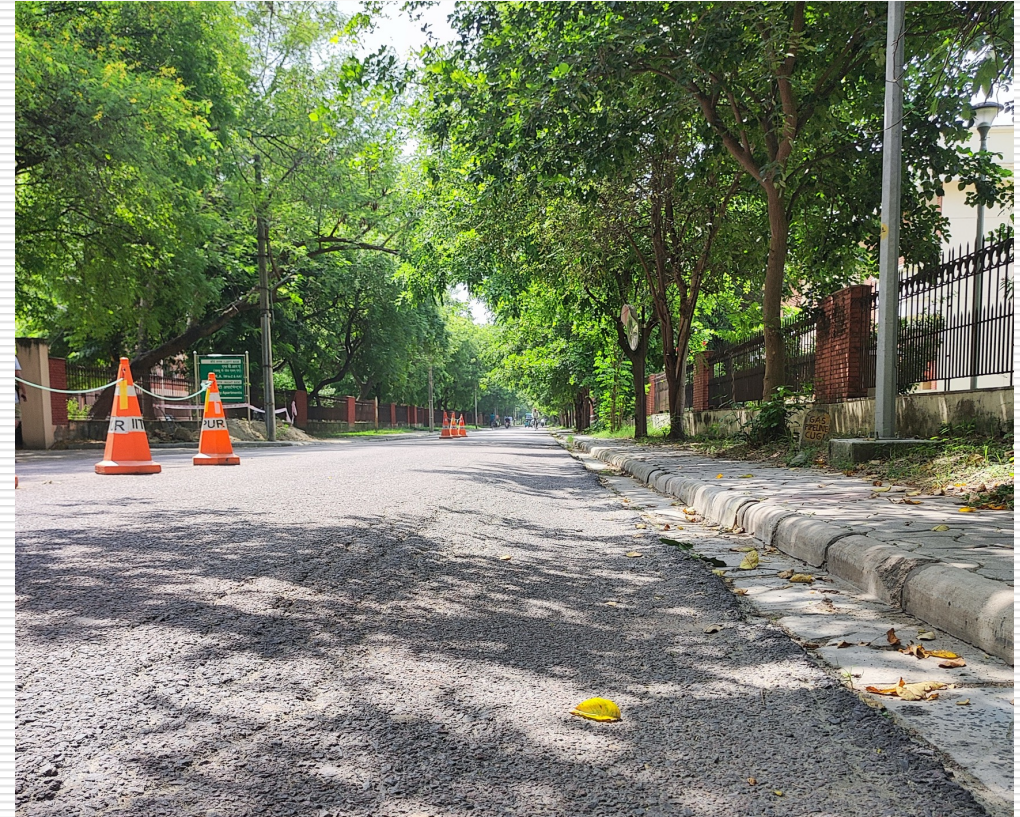
- ❑ Permanent deformation along the maximum travelled wheel path
- ❑ Depends on
 - traffic repetitions,
 - construction materials,
 - densification,
 - and pavement temperature
- ❑ Occurs in areas with heavy traffic or frequent heavy vehicles

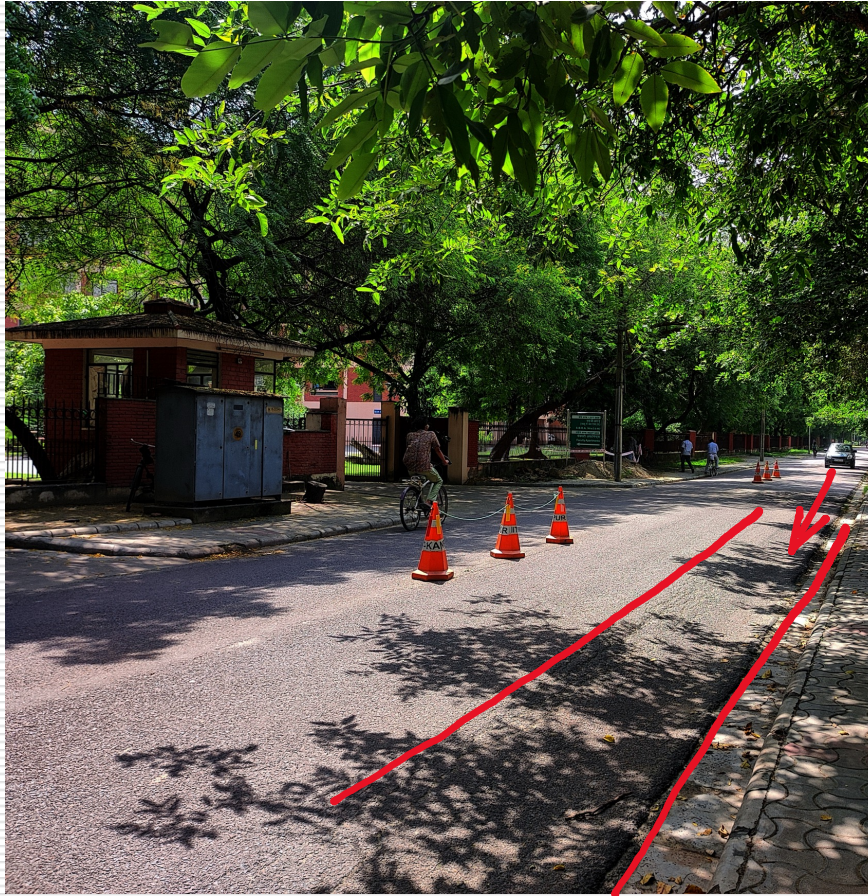
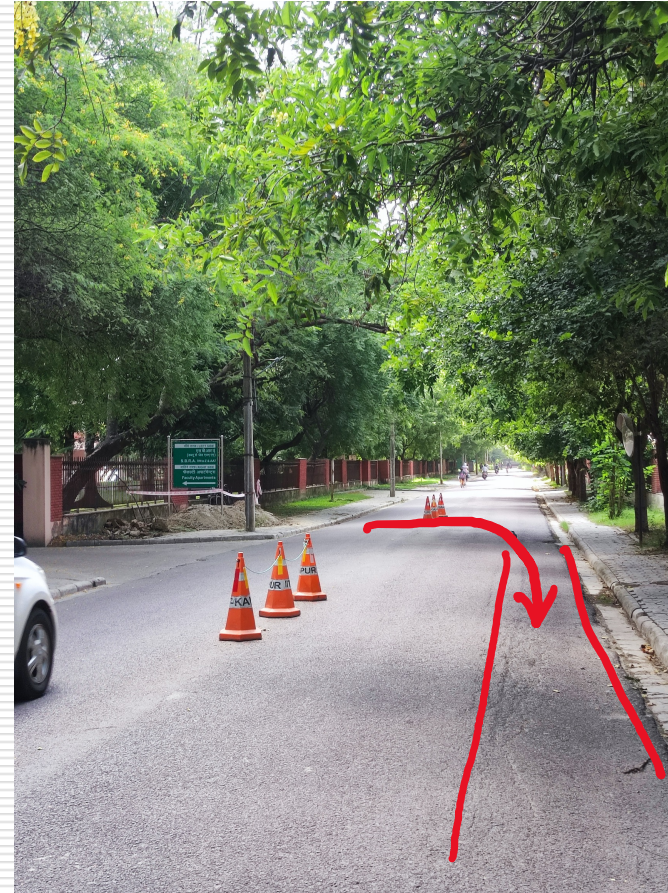
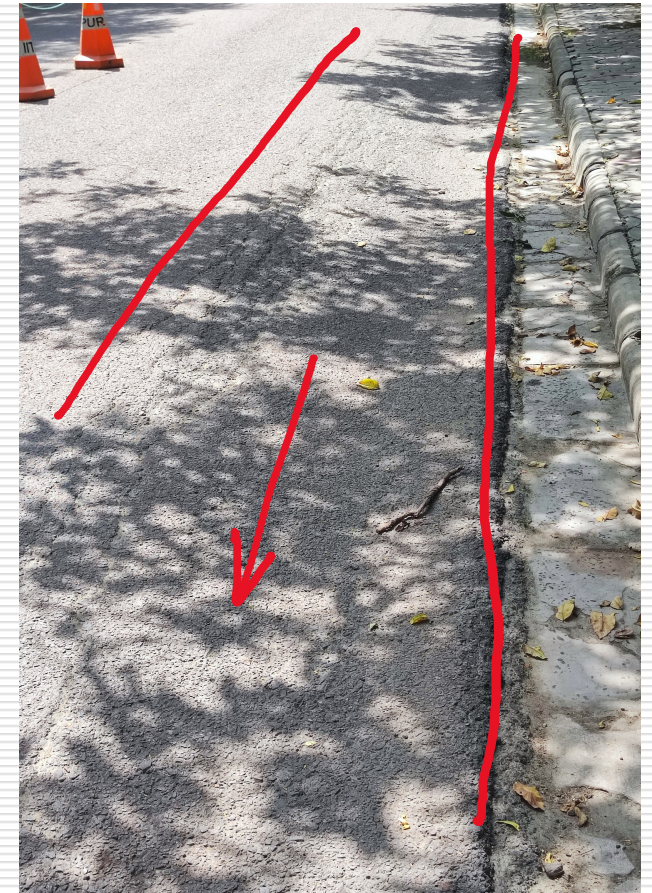
Rutting observed along the road extending from e-shop to Hall 6, specifically in the vicinity of the Faculty Apartments

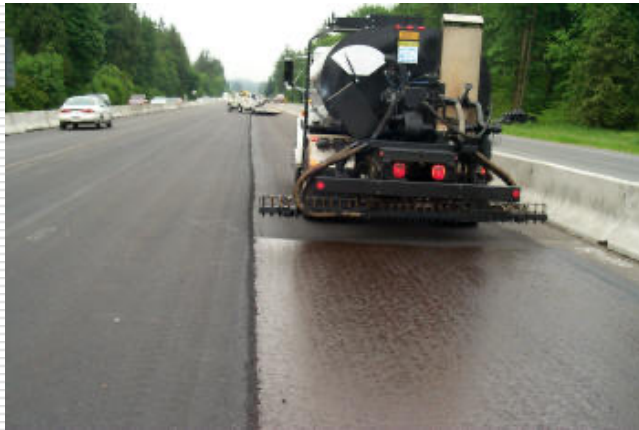
- ❑ Apply tack coat
- ❑ Compact to desired levels
- ❑ Apply a profile corrective course
- ❑ Fill ruts with premix patching materials (asphalt binder)

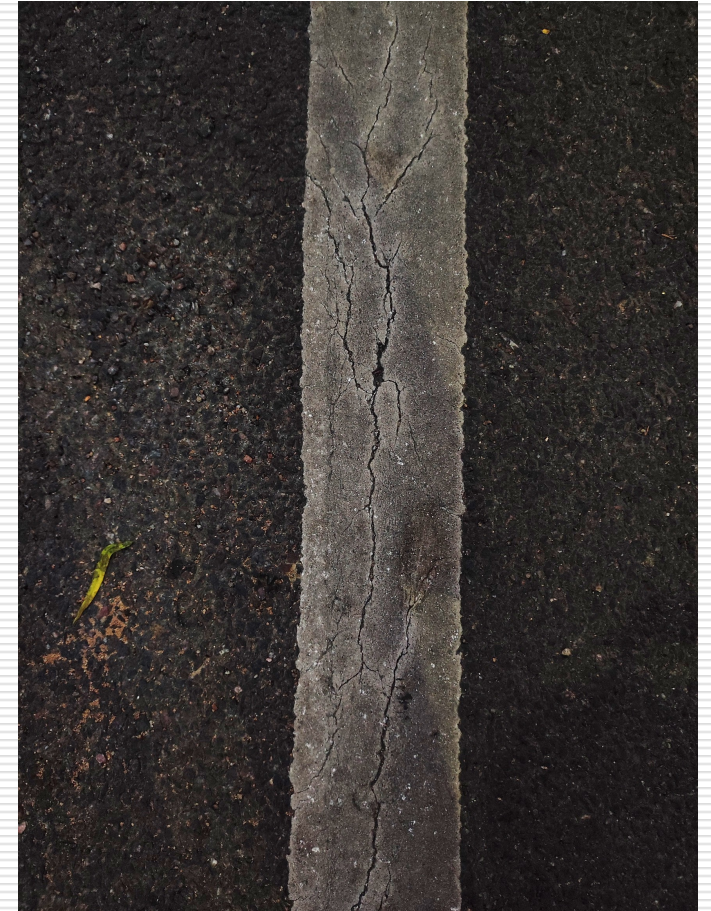
- ❑ 'Fatigue' of the bituminous materials
- ❑ Network of interconnected cracks
- ❑ Also known as Alligator Cracking
- ❑ Decreases pavement life
- ❑ Accelerates further deterioration

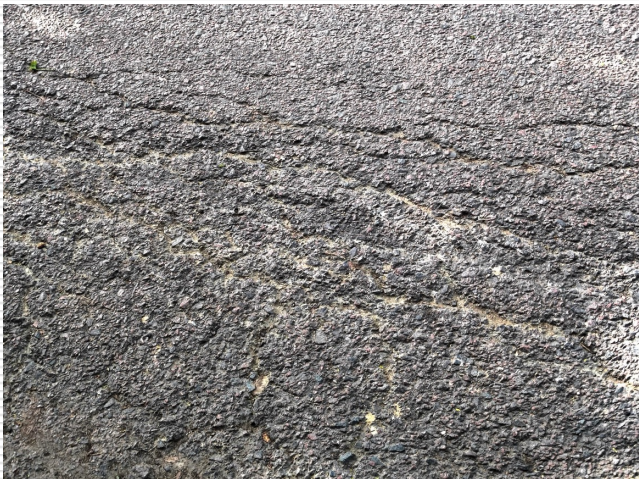
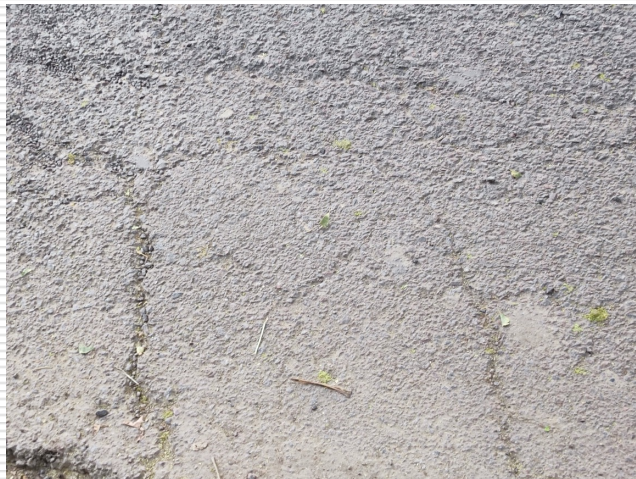
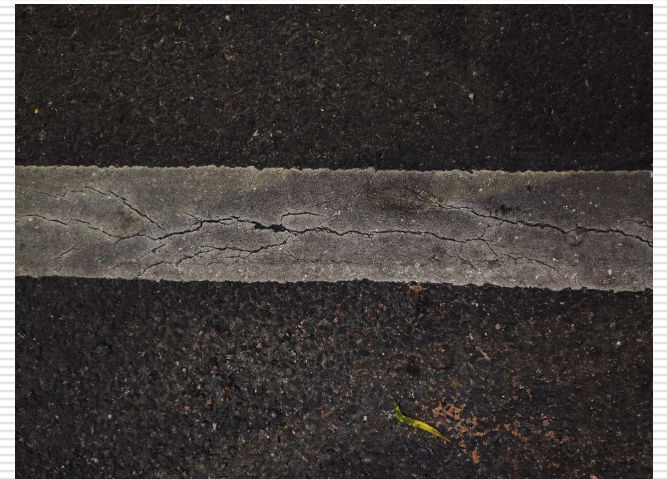
- Road from Kargil Heights to Hall 6
- Road from Hall 2 to Academic Gate 3
- Road from Hall 6 to E-Shop
- Near DoAA Canteen

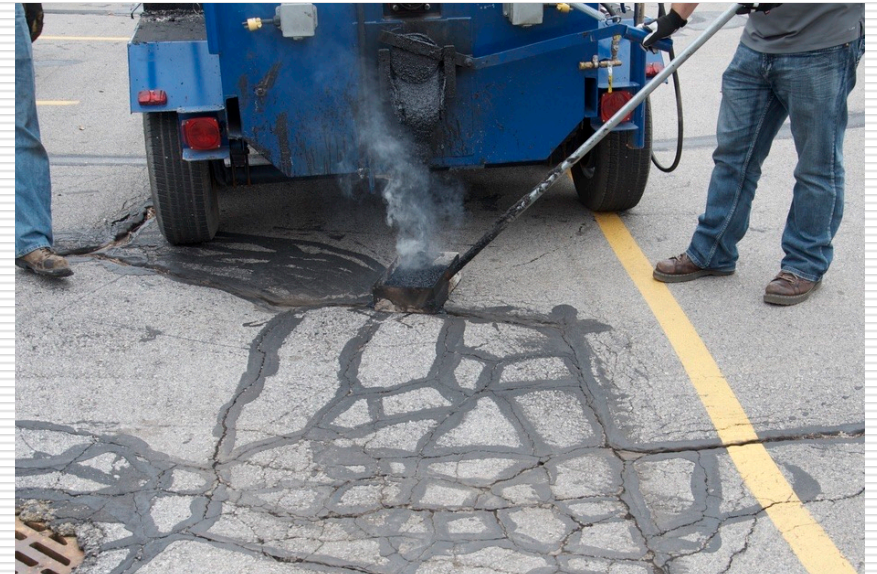
- ❑ Crack sealing by bitumen emulsions
- ❑ Crack sealing by rubberized and modified bitumen
- ❑ Milling and surface recycling
- ❑ Use of good quality binder materials

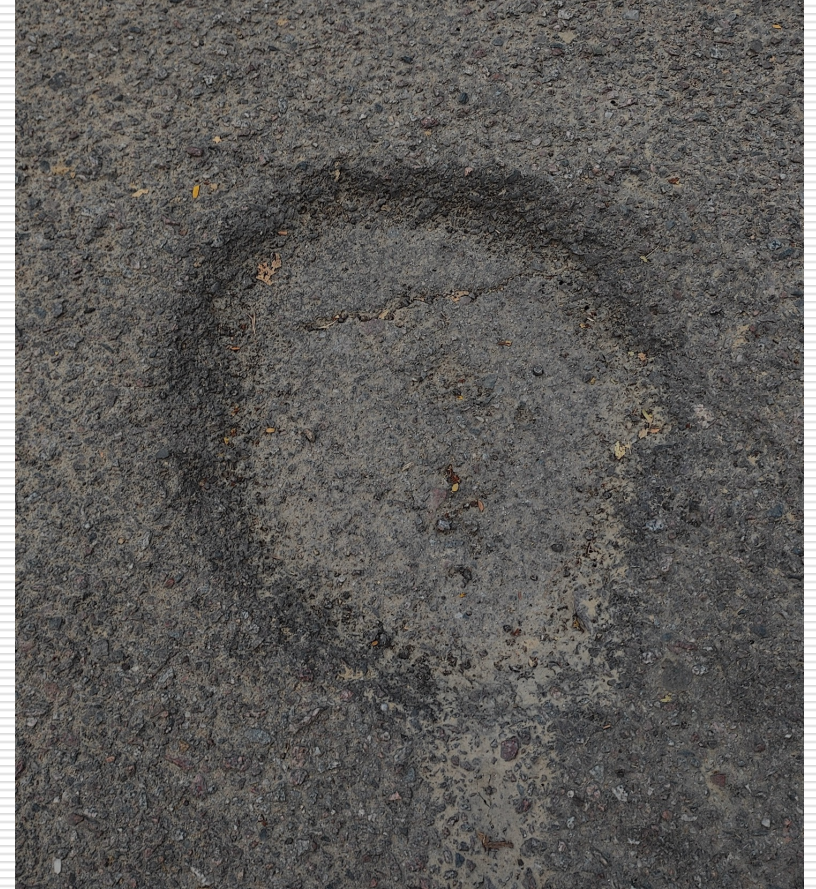
- ❑ Bowl-shaped holes on bituminous pavement
- ❑ Minimum Diameter:
(FHA Distress Identification Manual)
 - Circular potholes: ≥ 150 mm
 - Irregular potholes: Should fit a 150-mm circle
- ❑ Makes pavement accident prone

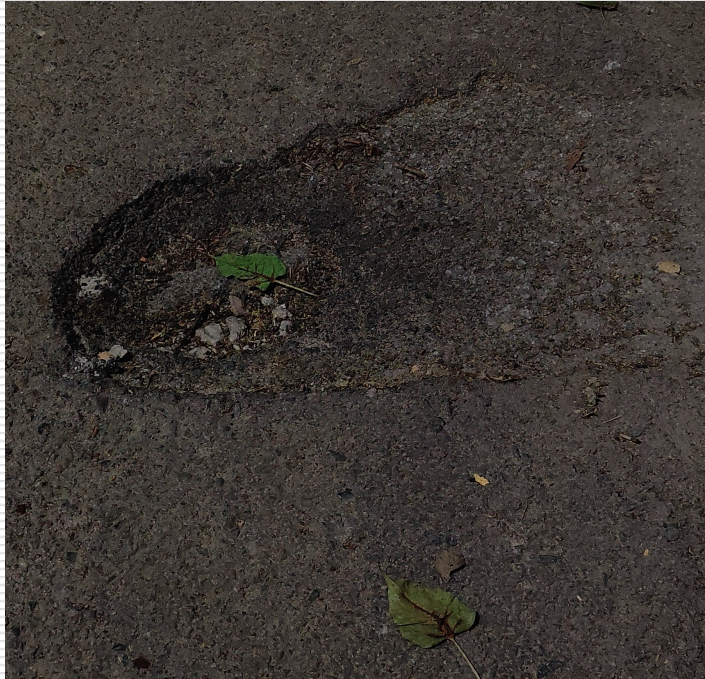
Pothole on road in front of campus e-shop

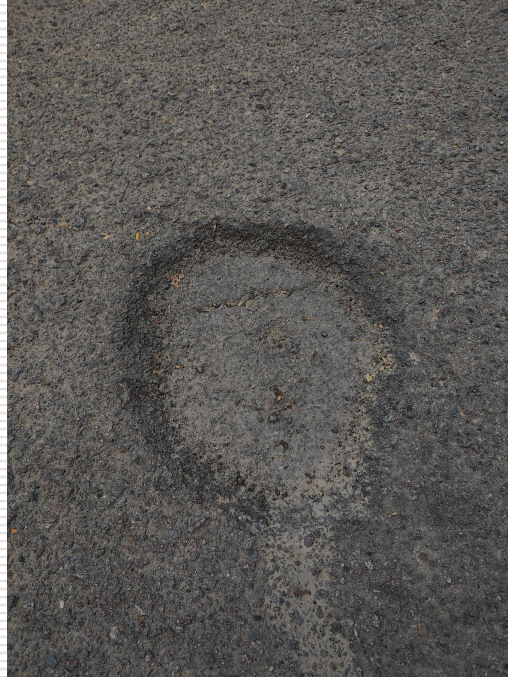
Pothole near the BSBE building, close to academic gate 3

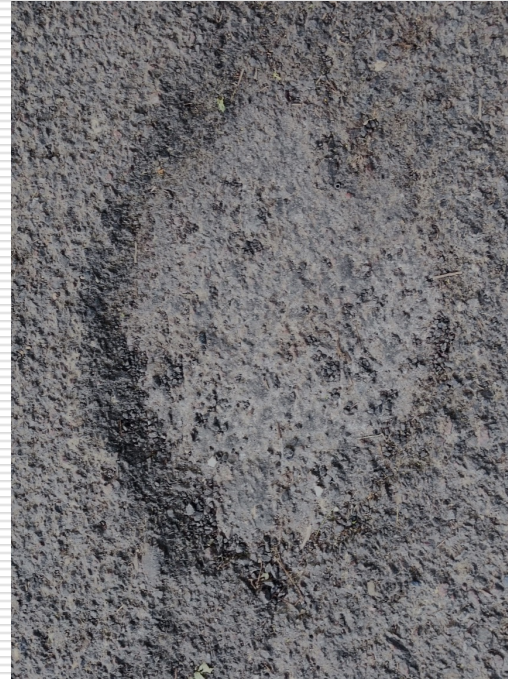
Pothole in front of Hall-2

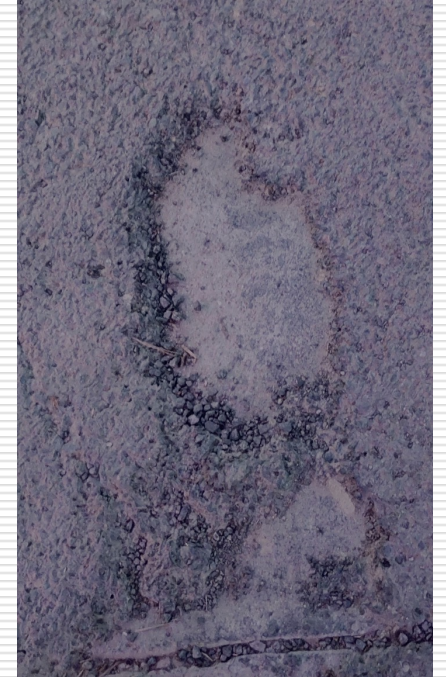
Pothole in front of Hall-1

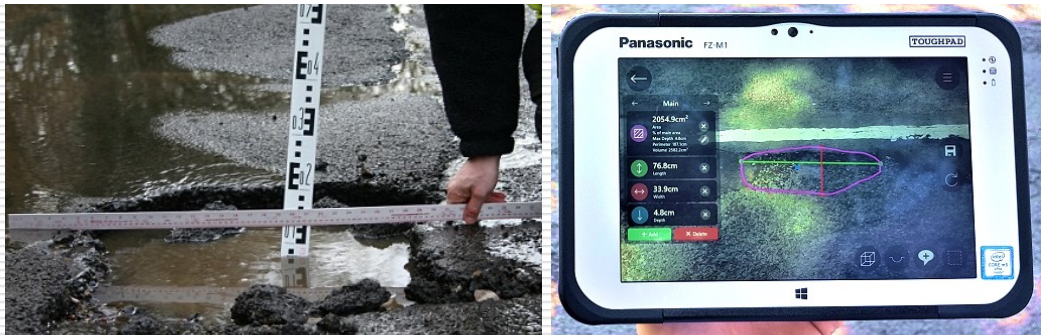
- ❑ Pothole depth is the maximum depth below pavement surface
- ❑ Severity Levels:
 - Low: < 25 mm deep
 - Moderate: 25 to 50 mm deep
 - High: > 50 mm deep

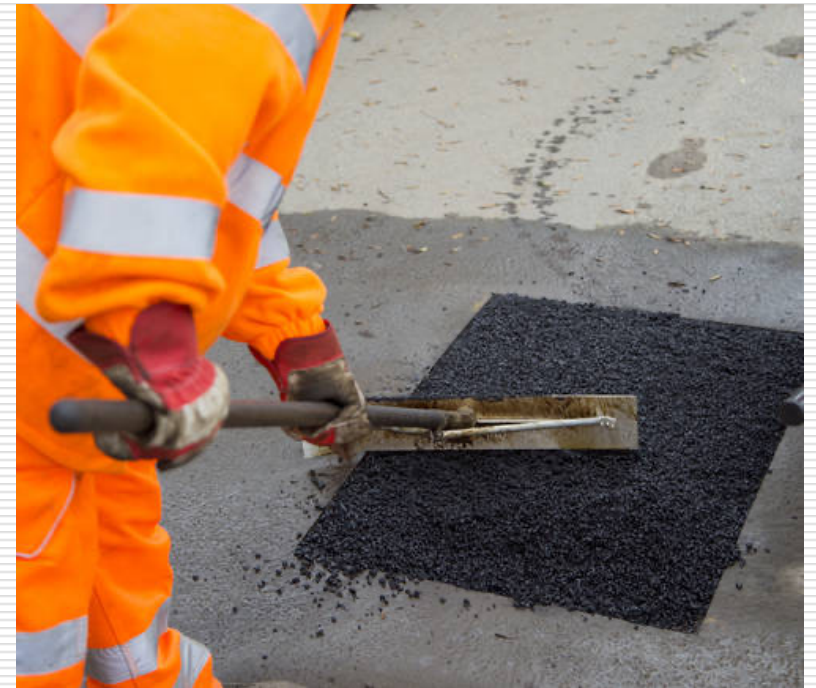
- Repairment by patchwork
- Use of high-quality asphalt materials
- Adequate drainage systems design

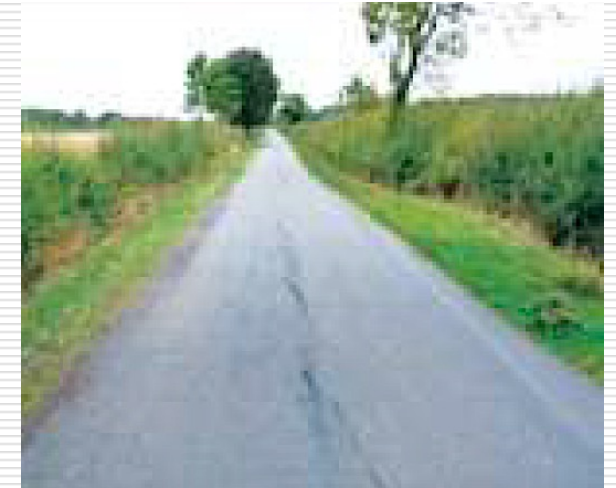
- ❑ Cracks parallel to the centerline or along the road
- ❑ Causes:
 - Alternate wetting and drying beneath the shoulder surface
- ❑ Effects:
 - Potential Alligator Cracking Source
 - Moisture infiltration, leading to further damage
 - Reduced ride quality
- ❑ Countermeasures:
 - Crack sealing using GGRB (Low/Medium severity)
 - Fresh overlay (High severity)

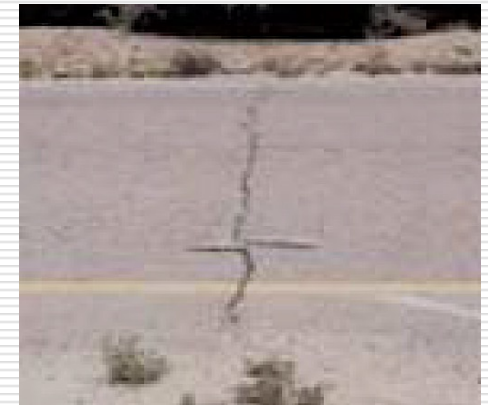
- ❑ Interconnected cracks forming series of large blocks perpendicular to the road's direction
- ❑ Causes:
 - Structural failure of CTB
 - Shrinkage of bituminous mix
- ❑ Effects:
 - Moisture infiltration, leading to further damage
 - Reduced pavement integrity
- ❑ Countermeasures:
 - Treatment using slurry seal or rubberized bitumen

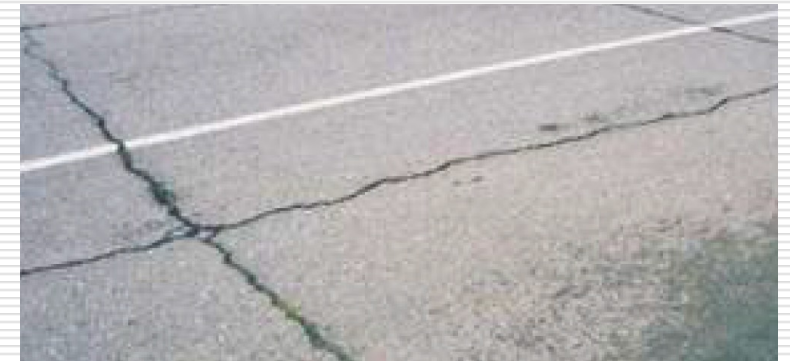
- Propagation of cracks formed in CTB layer to the bit. layer
- Causes:
 - Construction vehicle
 - Thermal and moisture changes in CTB
- Effects:
 - Early-stage damage of pavement
 - Moisture infiltration, leading to further damage
- Countermeasures:
 - Aggregate inter layer (100mm)
 - SAMI (thin and polymeric)

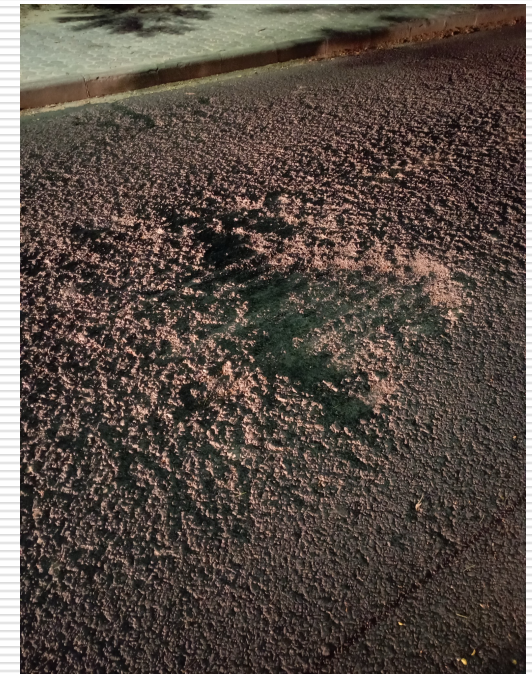
- ❑ Undulations due to plastic deformation of top bituminous surface
- ❑ Causes:
 - Lack of stability of asphalt mixtures in warm weather
 - Increased horizontal force during vehicle start or stop
- ❑ Effects:
 - Discomfort during driving
- ❑ Countermeasures:
 - Apply a new surfacing layer
 - Thoroughly roll the treated area for compaction
- ❑ In Campus:
 - Road in front of Hall 2

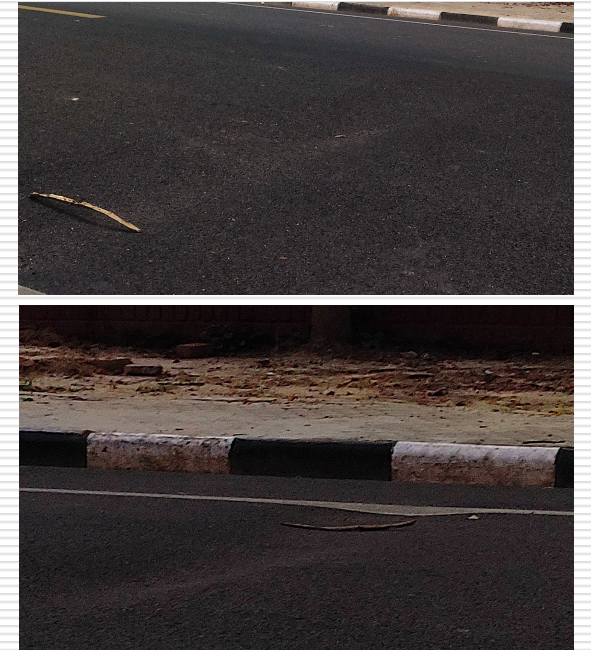
- Localized area where the pavement sinks relative to the finished surface
- Causes:
 - Differential settlement of subgrade
 - Inappropriate mix design
- Effects:
 - Water accumulation and further damage
 - Affects riding quality
- Countermeasures:
 - Filling with premix aggregates followed by compaction
- In Campus:
 - Road from Kargil heights to H6 near KV School

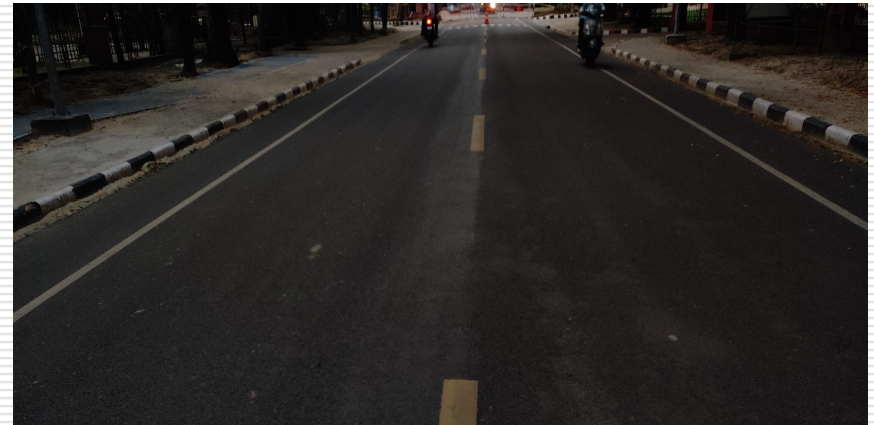
- Smoothing of pavement surface
- Causes:
 - Repetitive passage of traffic
 - Less abrasive strength of aggregates
- Effects:
 - Lower Skid Resistance
- Countermeasures:
 - Replacement of top course with angular aggregate
 - Applying a skid-resistant slurry seal or overlay
- In Campus:
 - Road from Kargil heights to Hall 6

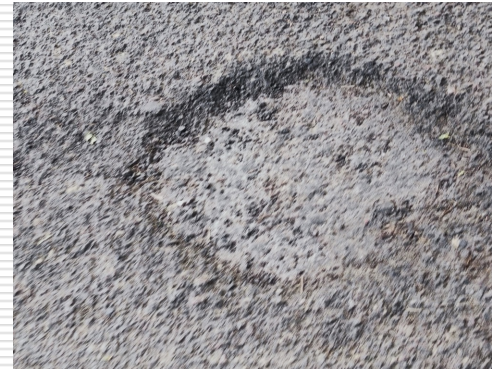
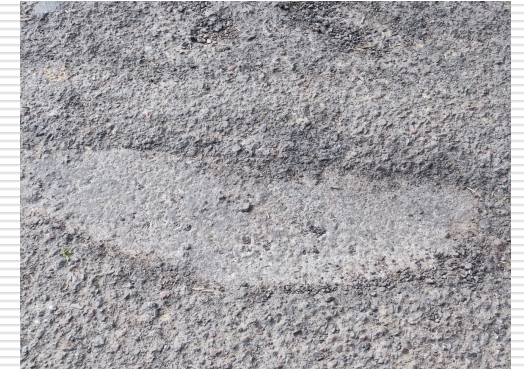
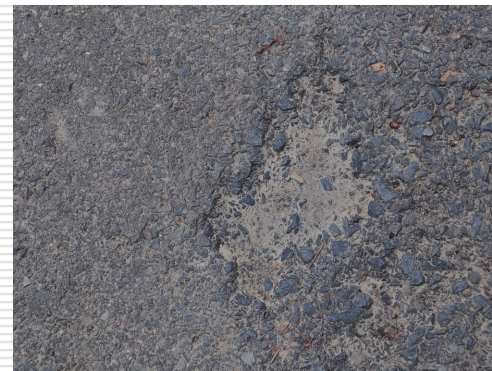
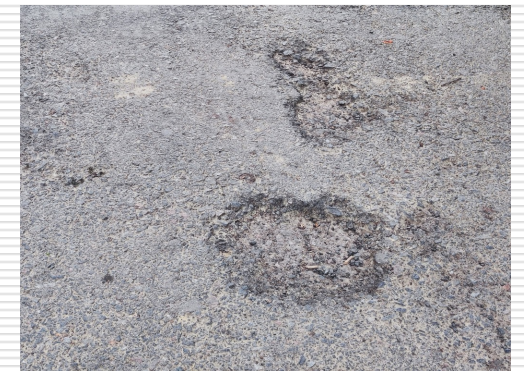
- ❑ Gradual wearing of top surface
- ❑ Causes:
 - Weathering of bitumen
 - Aging of pavement
- ❑ Effects:
 - Faster Deterioration
 - Contributes to Pothole formation
- ❑ Countermeasures:
 - Coat of slurry seal
- ❑ In Campus:
 - Road in front of MT, Technopark, Hall 2

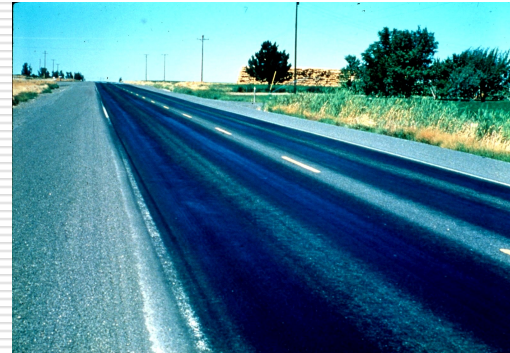
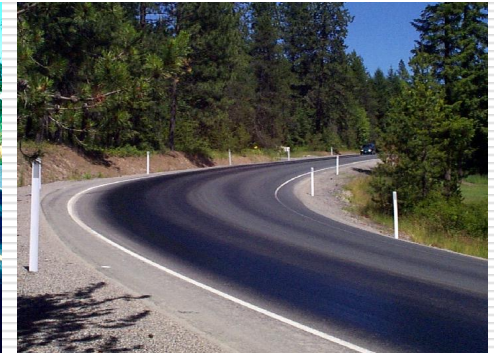
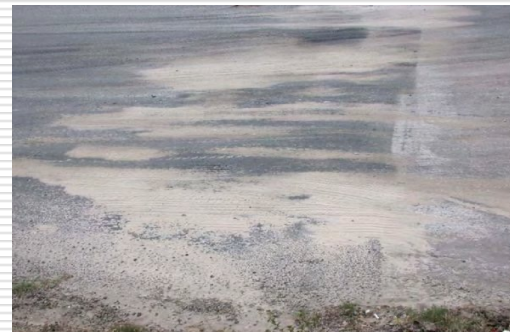
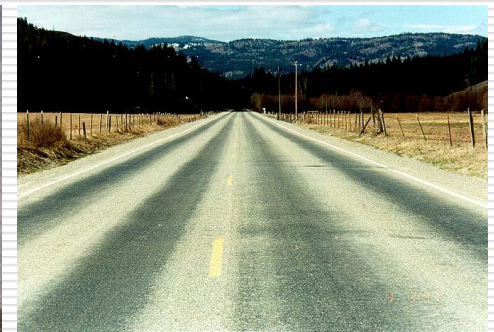
- ❑ Upward movement of excess asphalt/bituminous binder
- ❑ Causes:
 - Heavy tack coats
 - High Temperature
- ❑ Effects:
 - Decreased ride quality
 - Lead to low skid resistance
- ❑ Countermeasures:
 - Proper Mix Design
 - Sand blotting
